BUREAU OF SHIPS GROUP
TECHNICAL INSPECTION REPORT

⑥ OPERATION CROSSROADS.
U.S.S HUGHES (DD410).
TEST BAKER.

VOLUME II [u] ⑧

USS HUGHES (DD410)

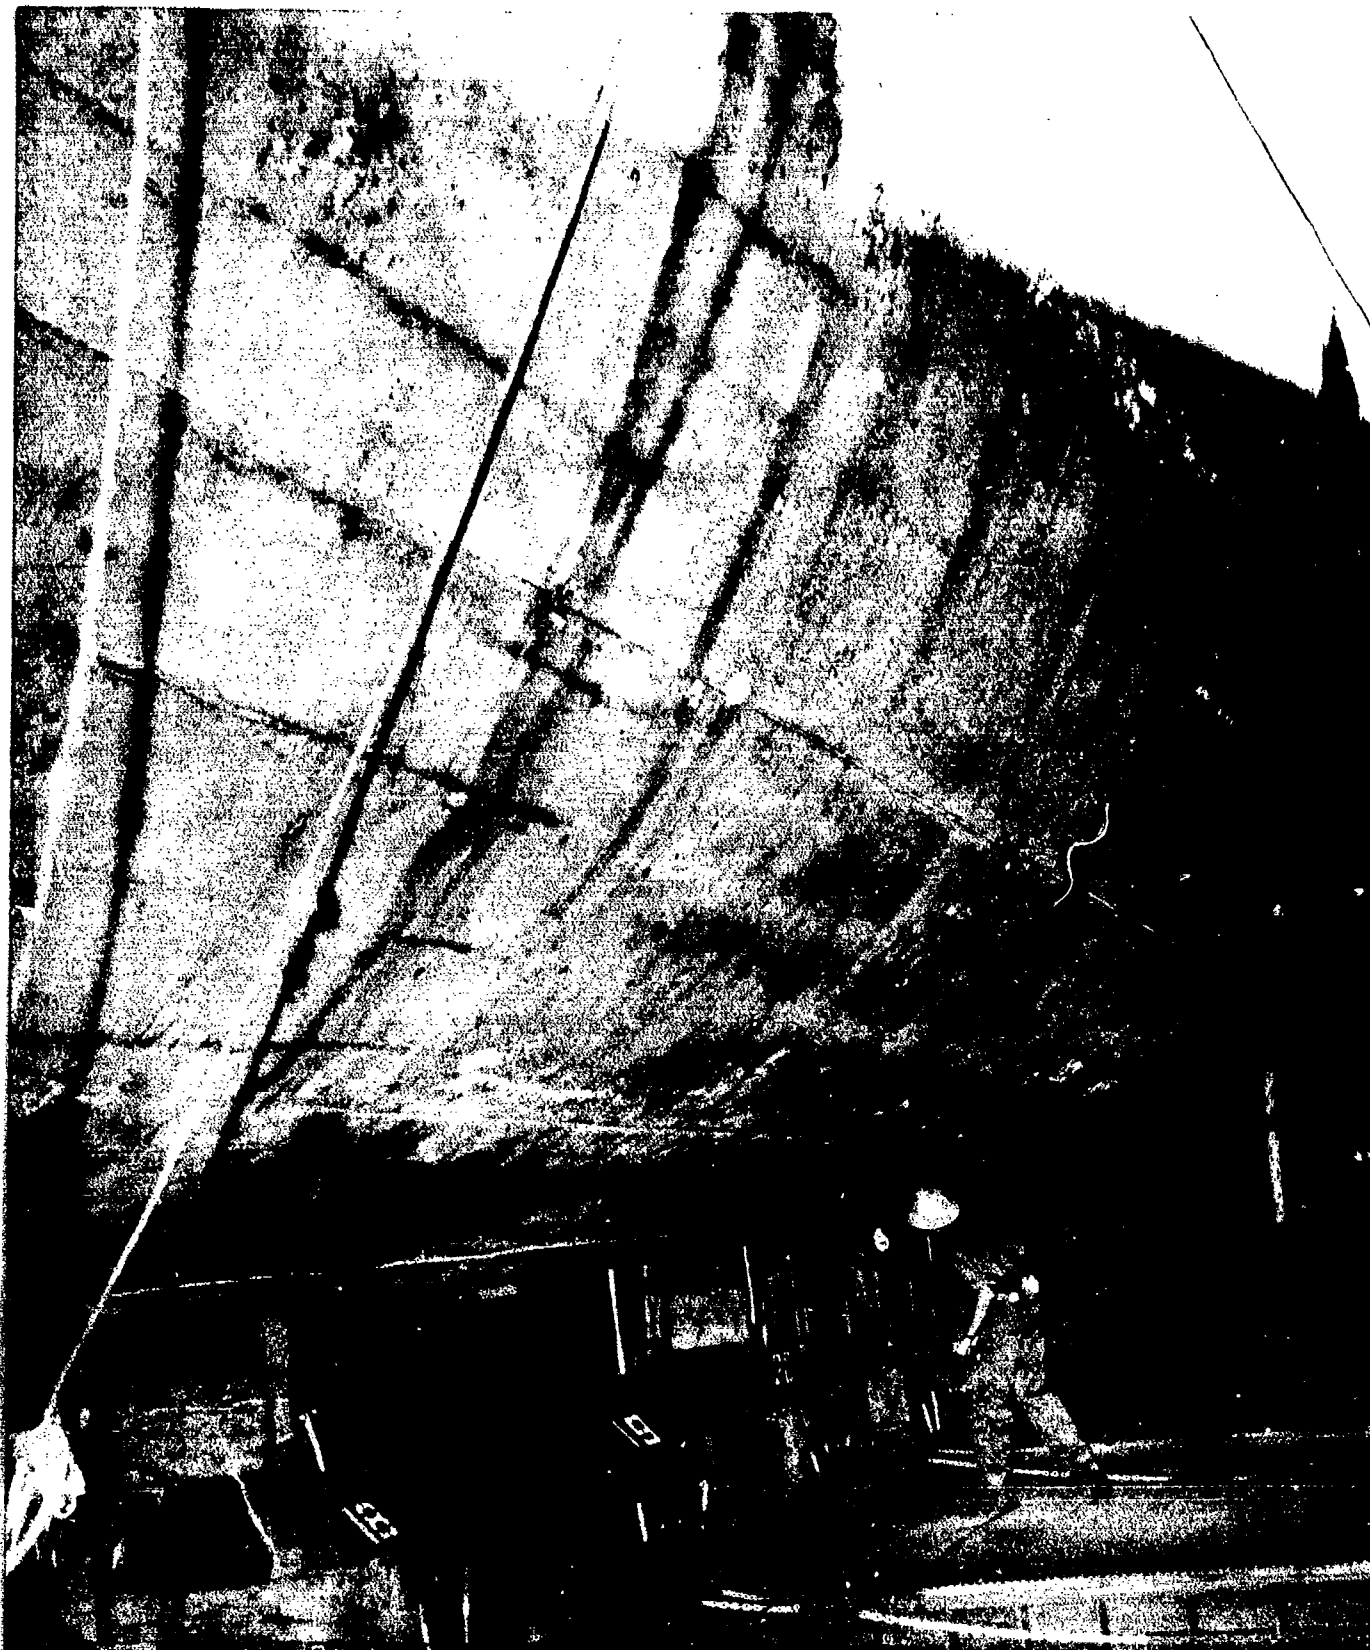
AB-CR-97-4048-3. Port shell looking aft, frames 40-60.

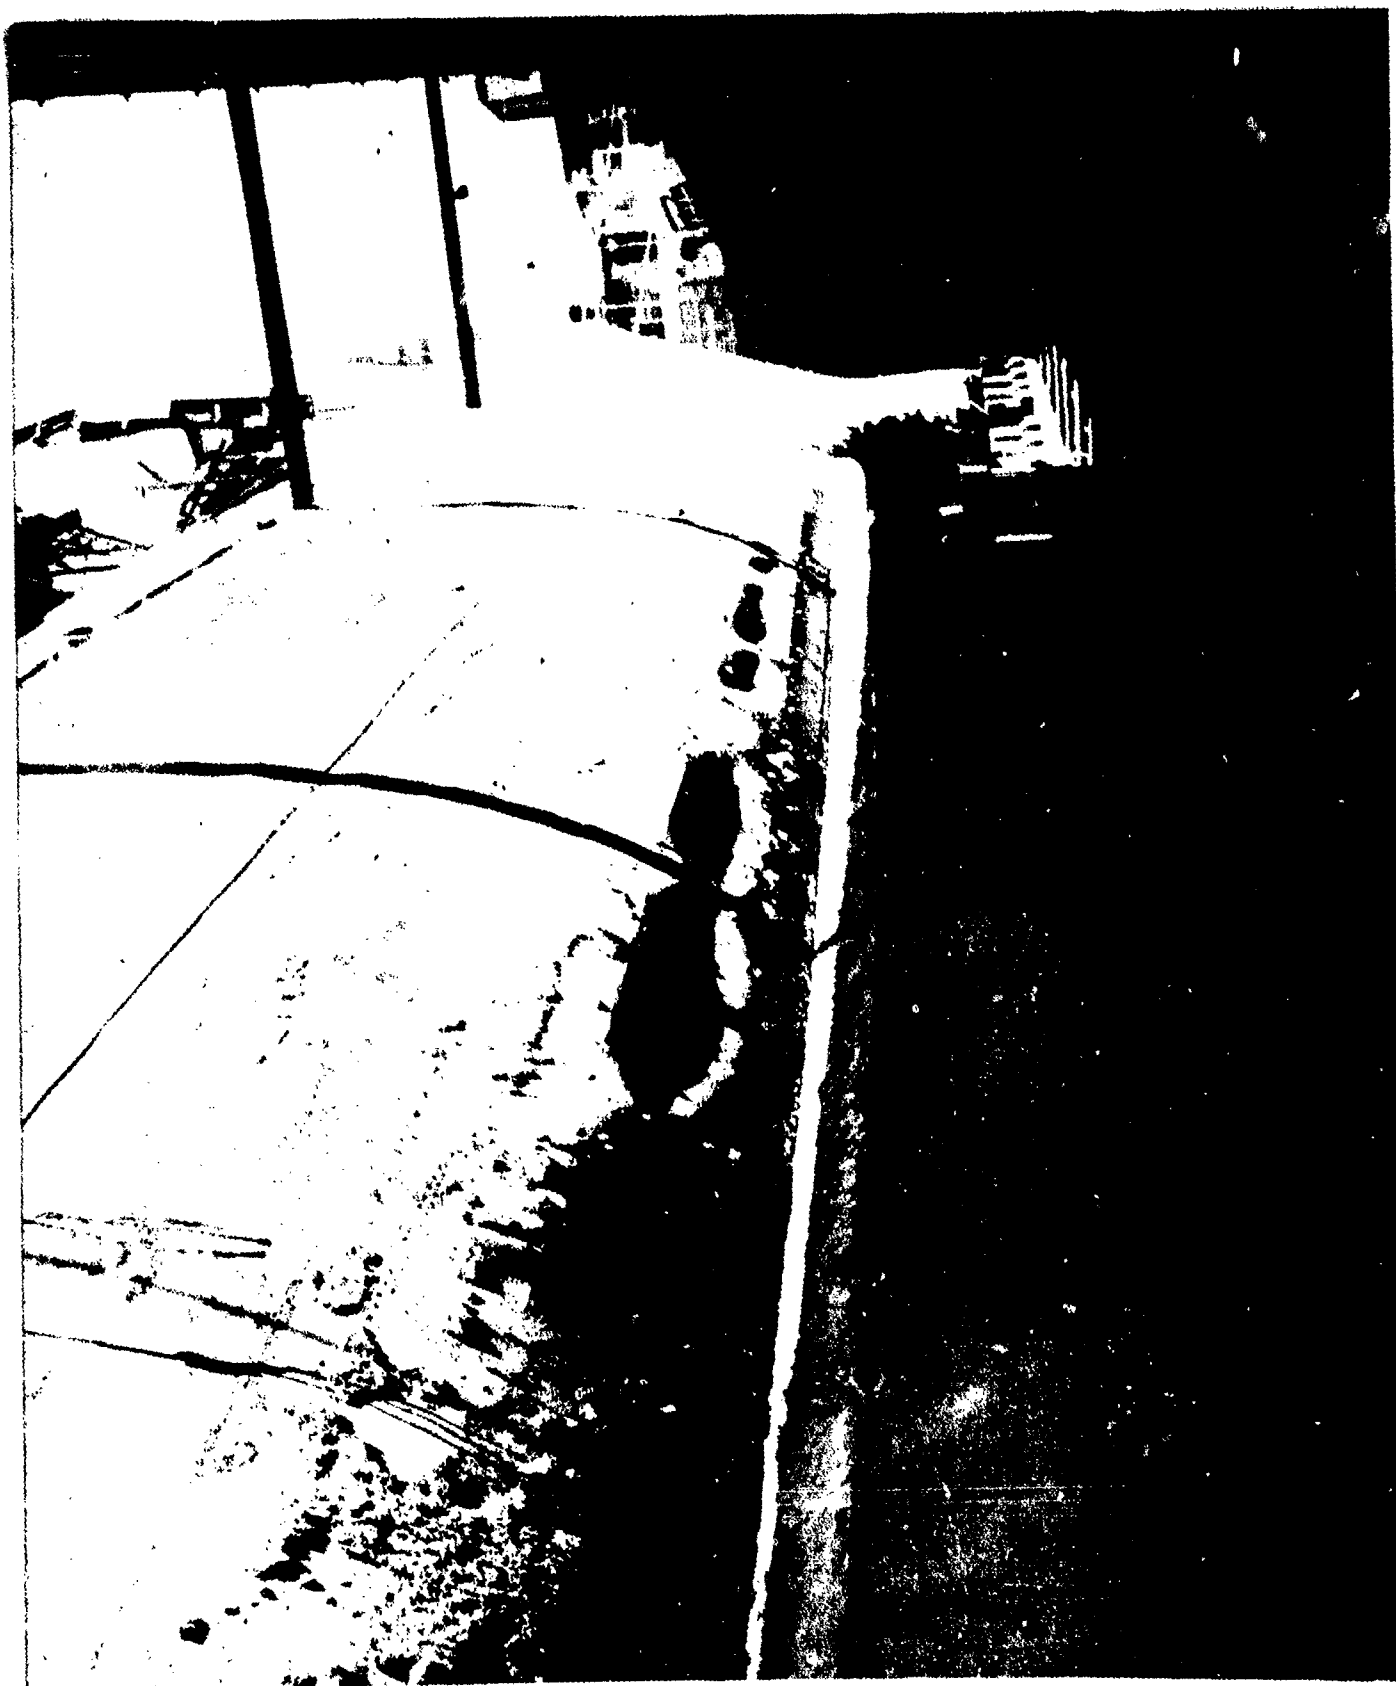
AB-CR-234-4062-3. Looking forward along port side showing buckles in shell plating above bilge keel.

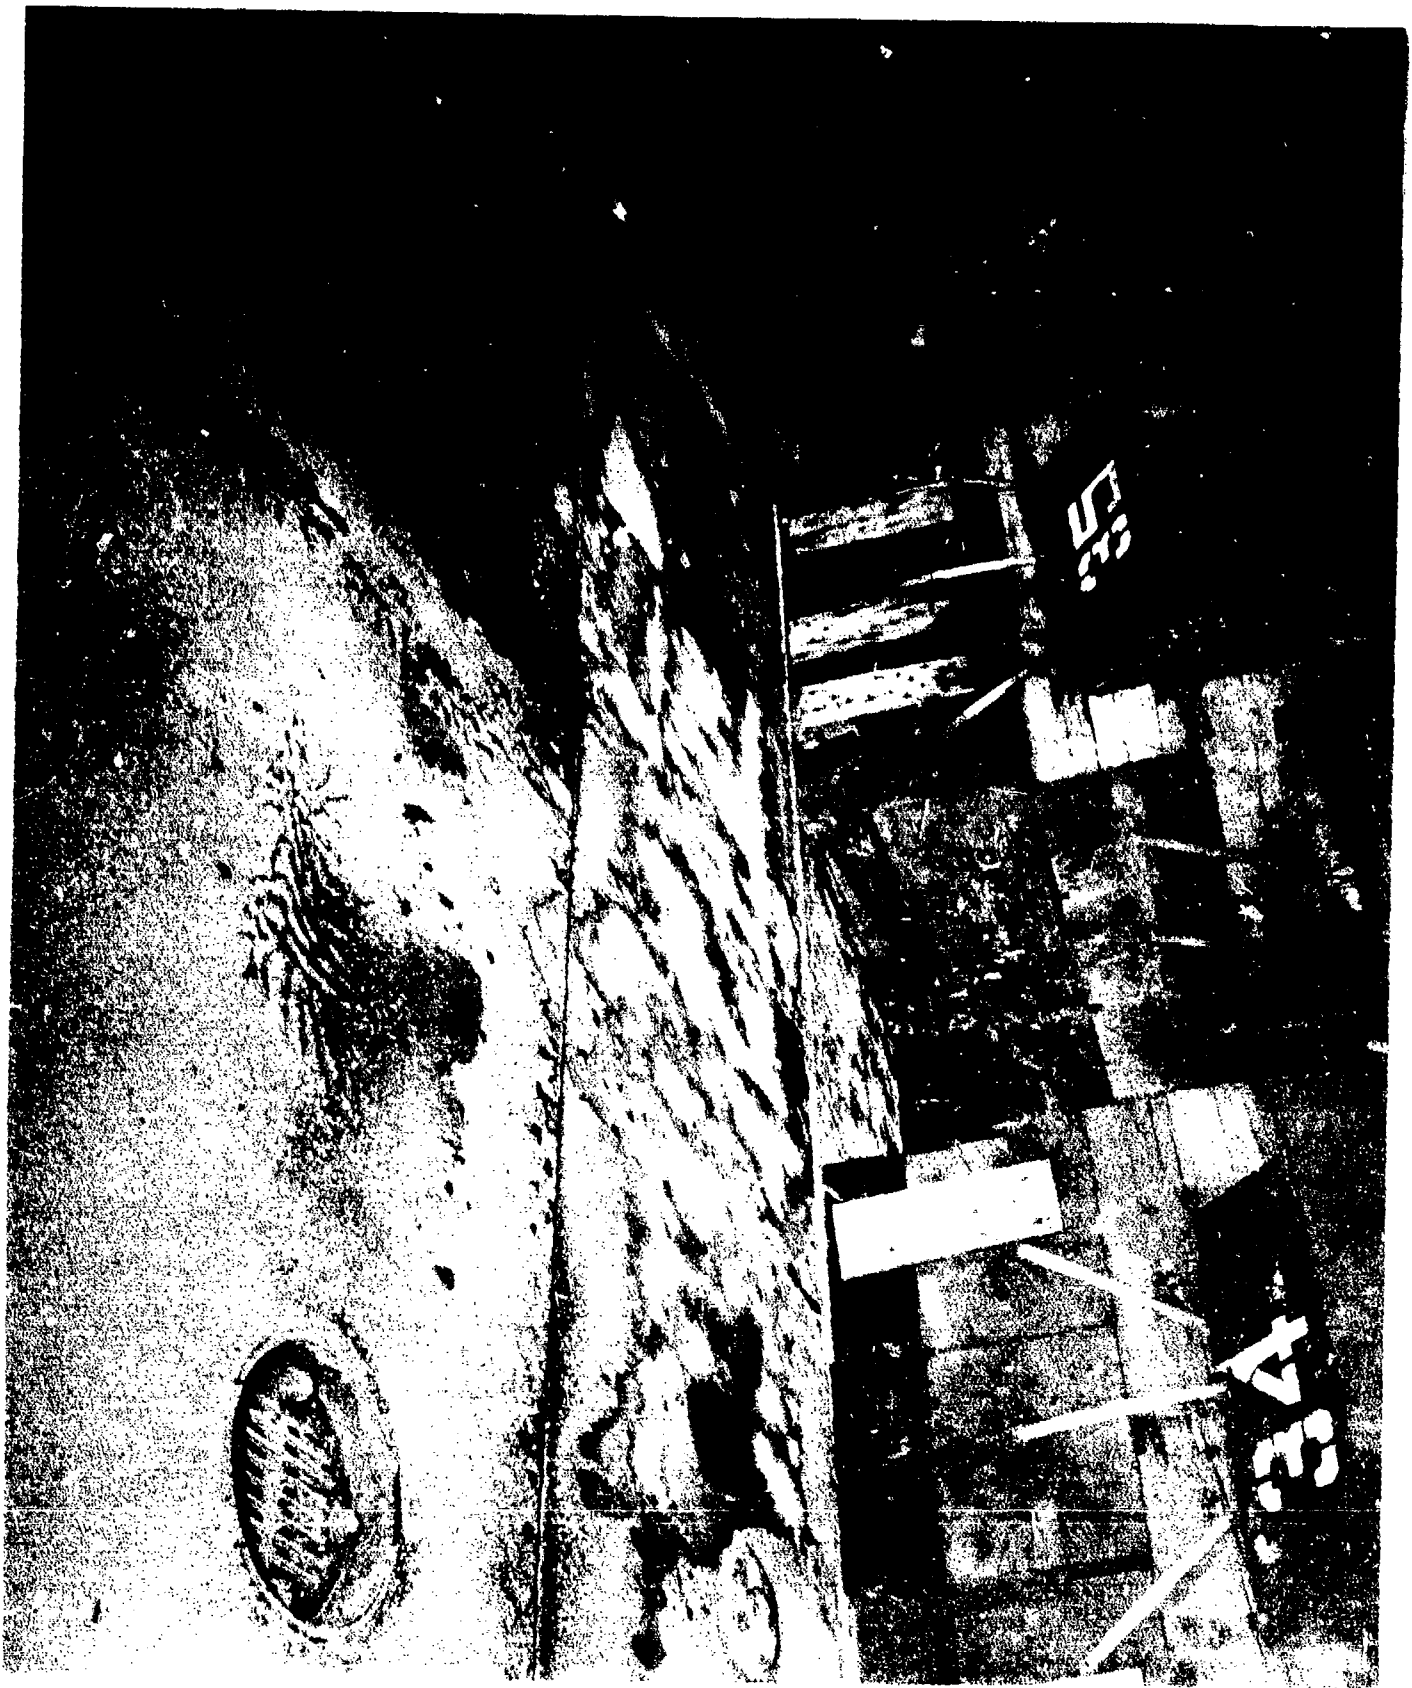
AB-CR-97-4048-7. Port bottom shell looking aft, frame 99-102.

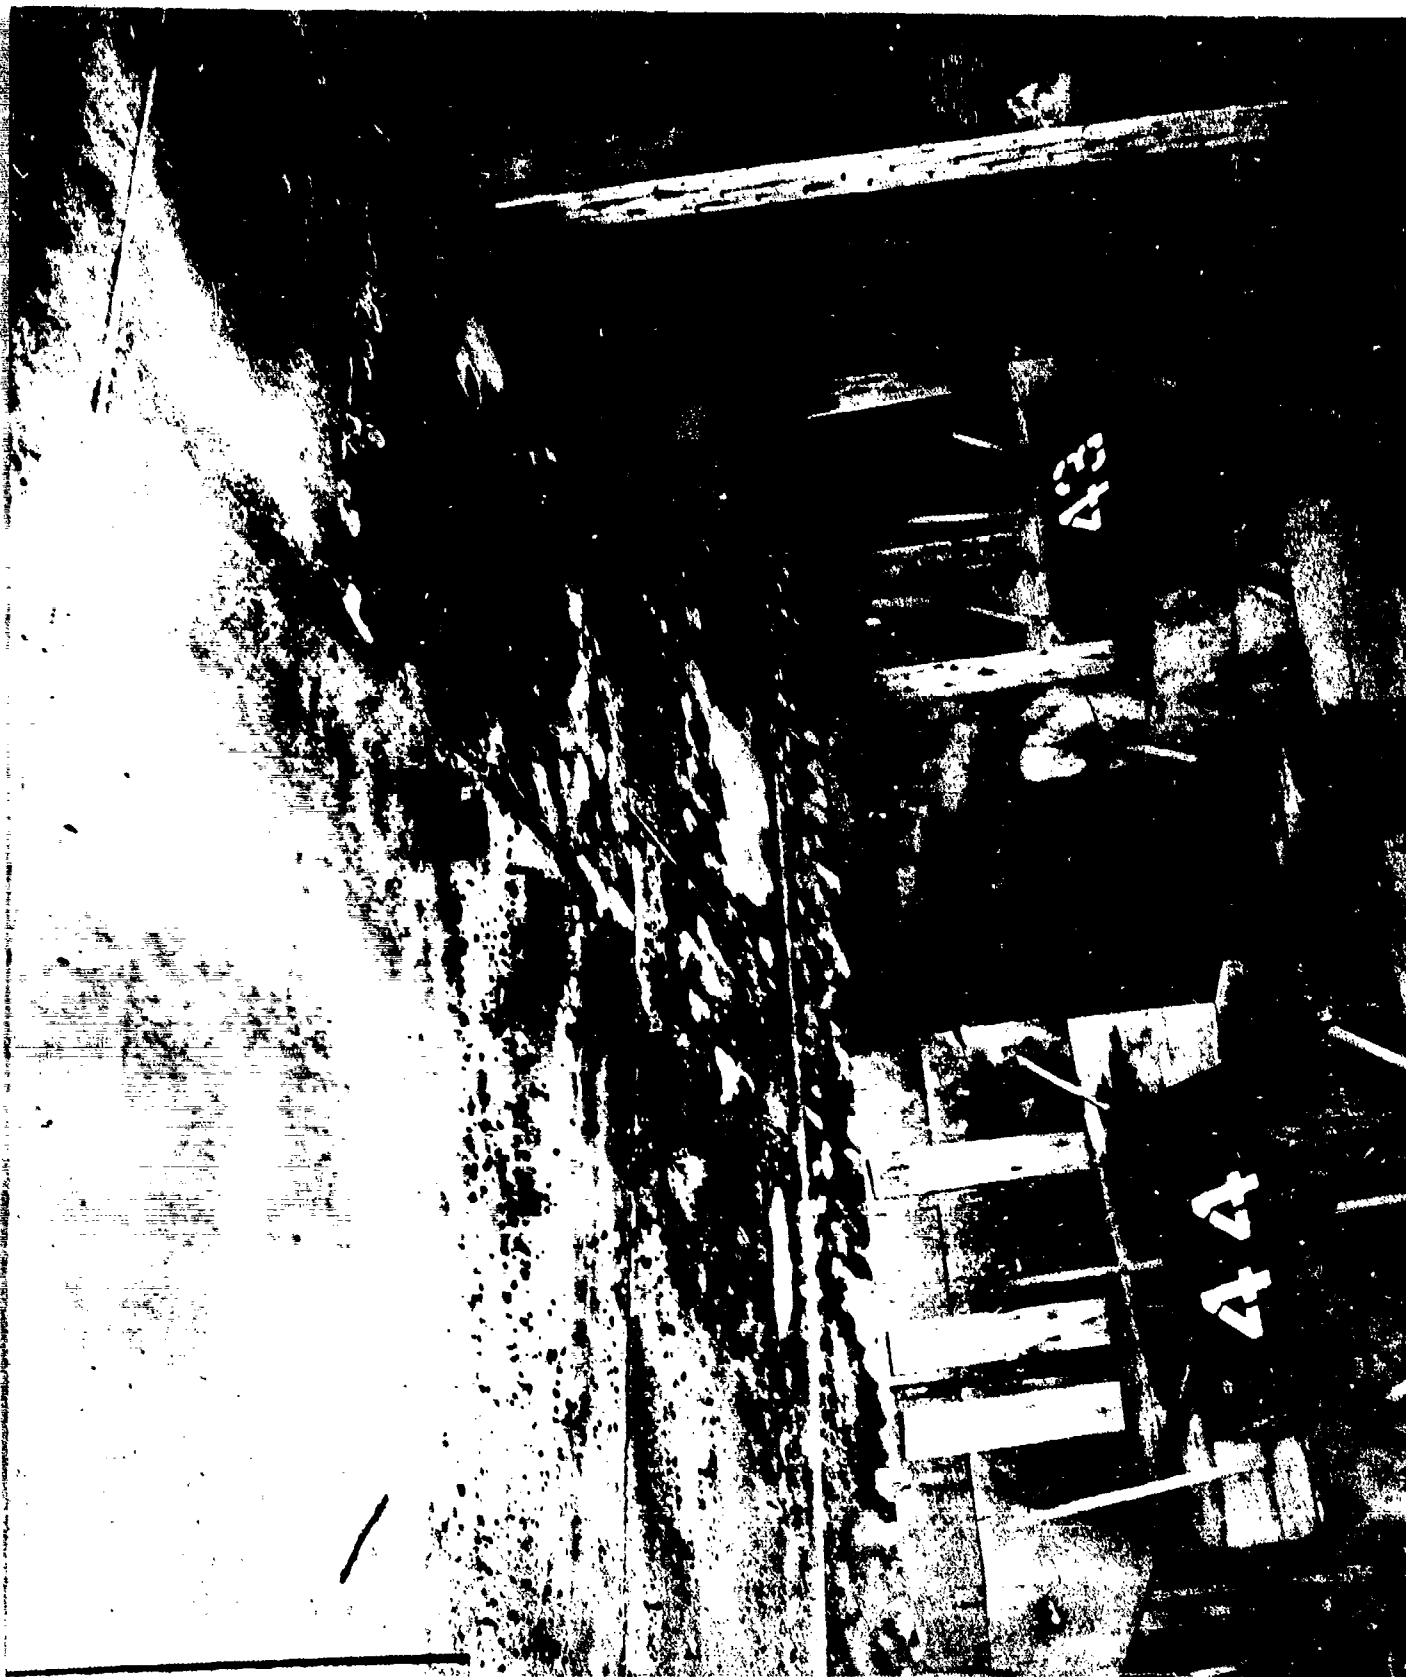
AB-CR-97-4049-6. Starboard bottom shell, looking inboard between frames 132-135.

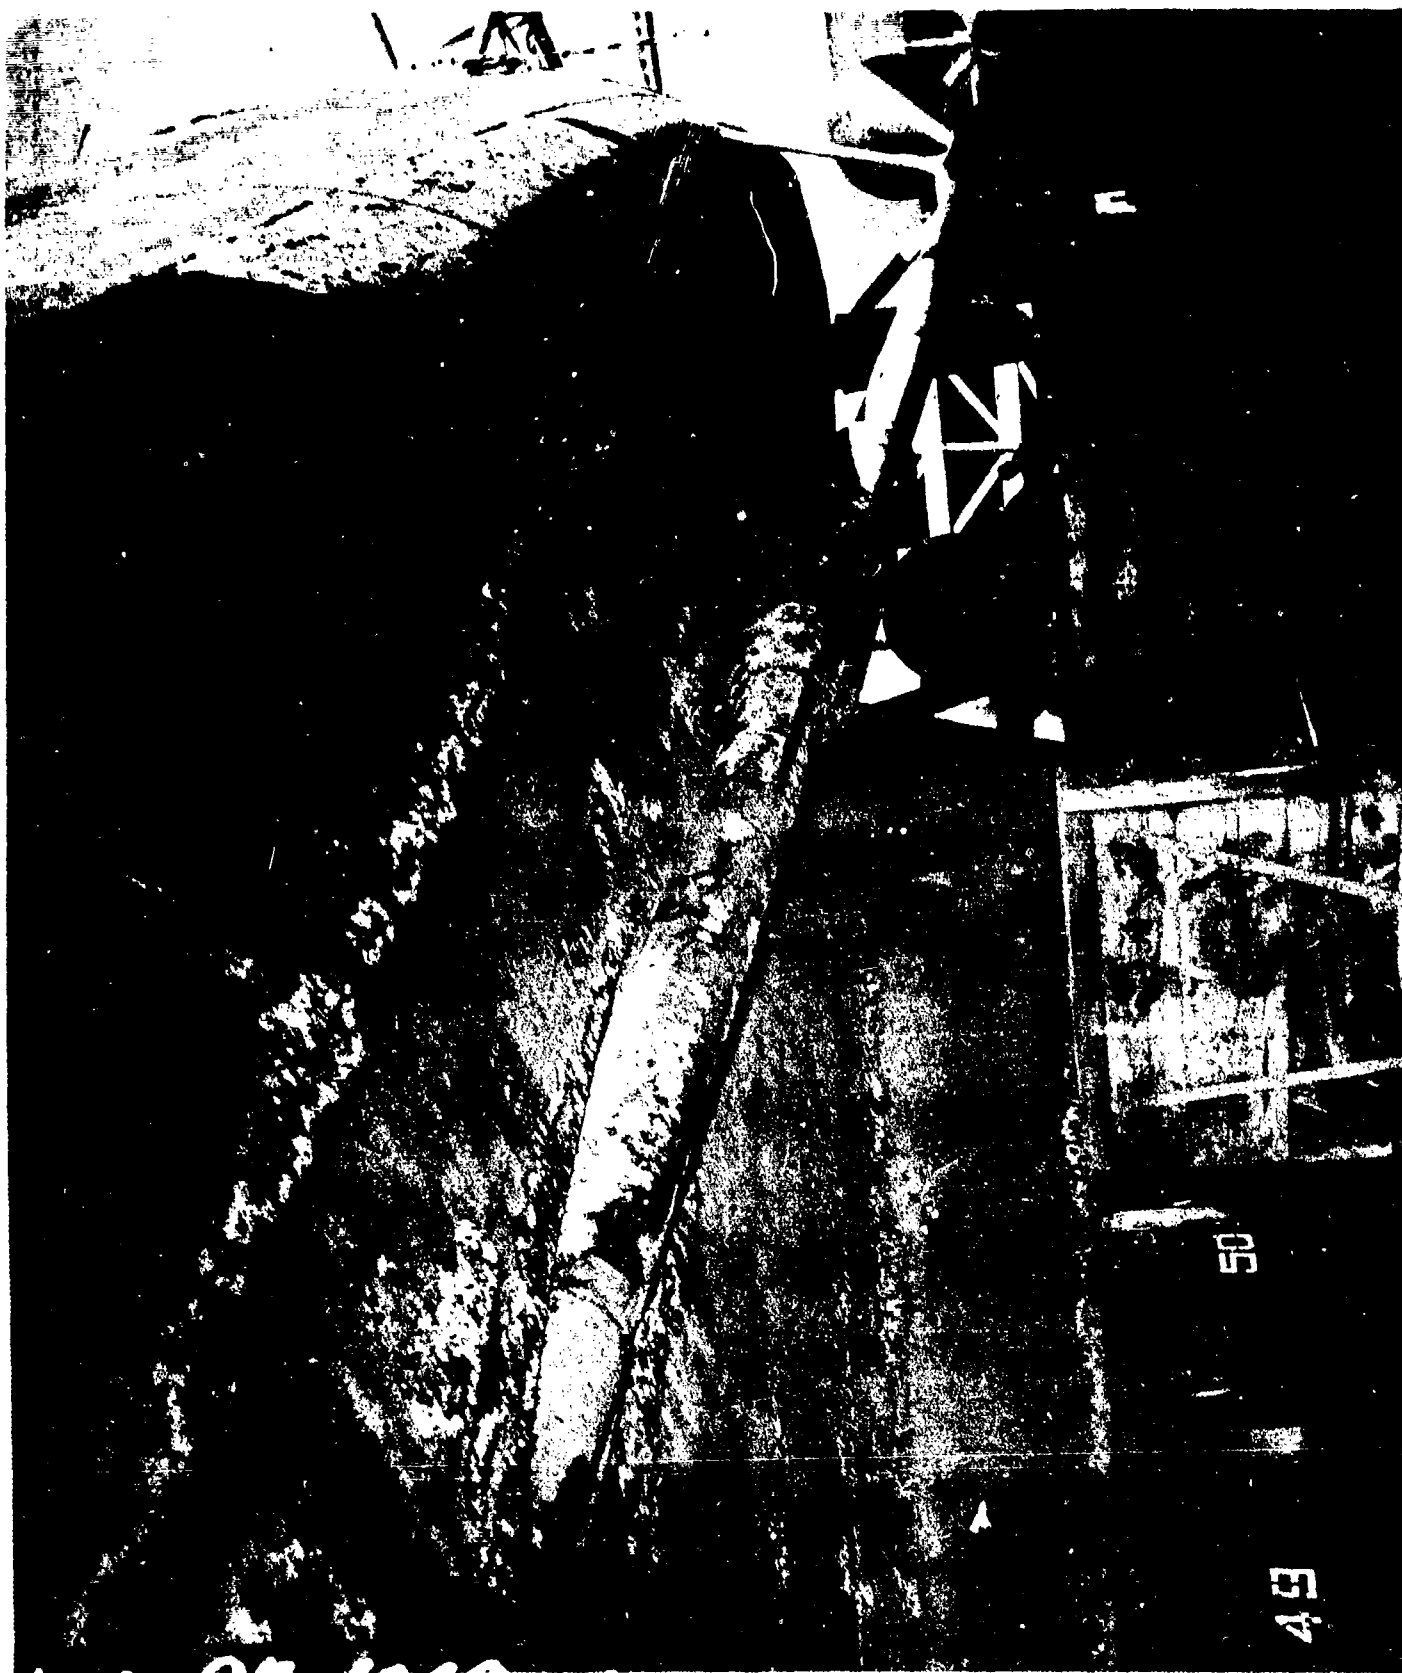
AB-CR-97-4049-1. Looking aft along port bottom shell from frame 150.

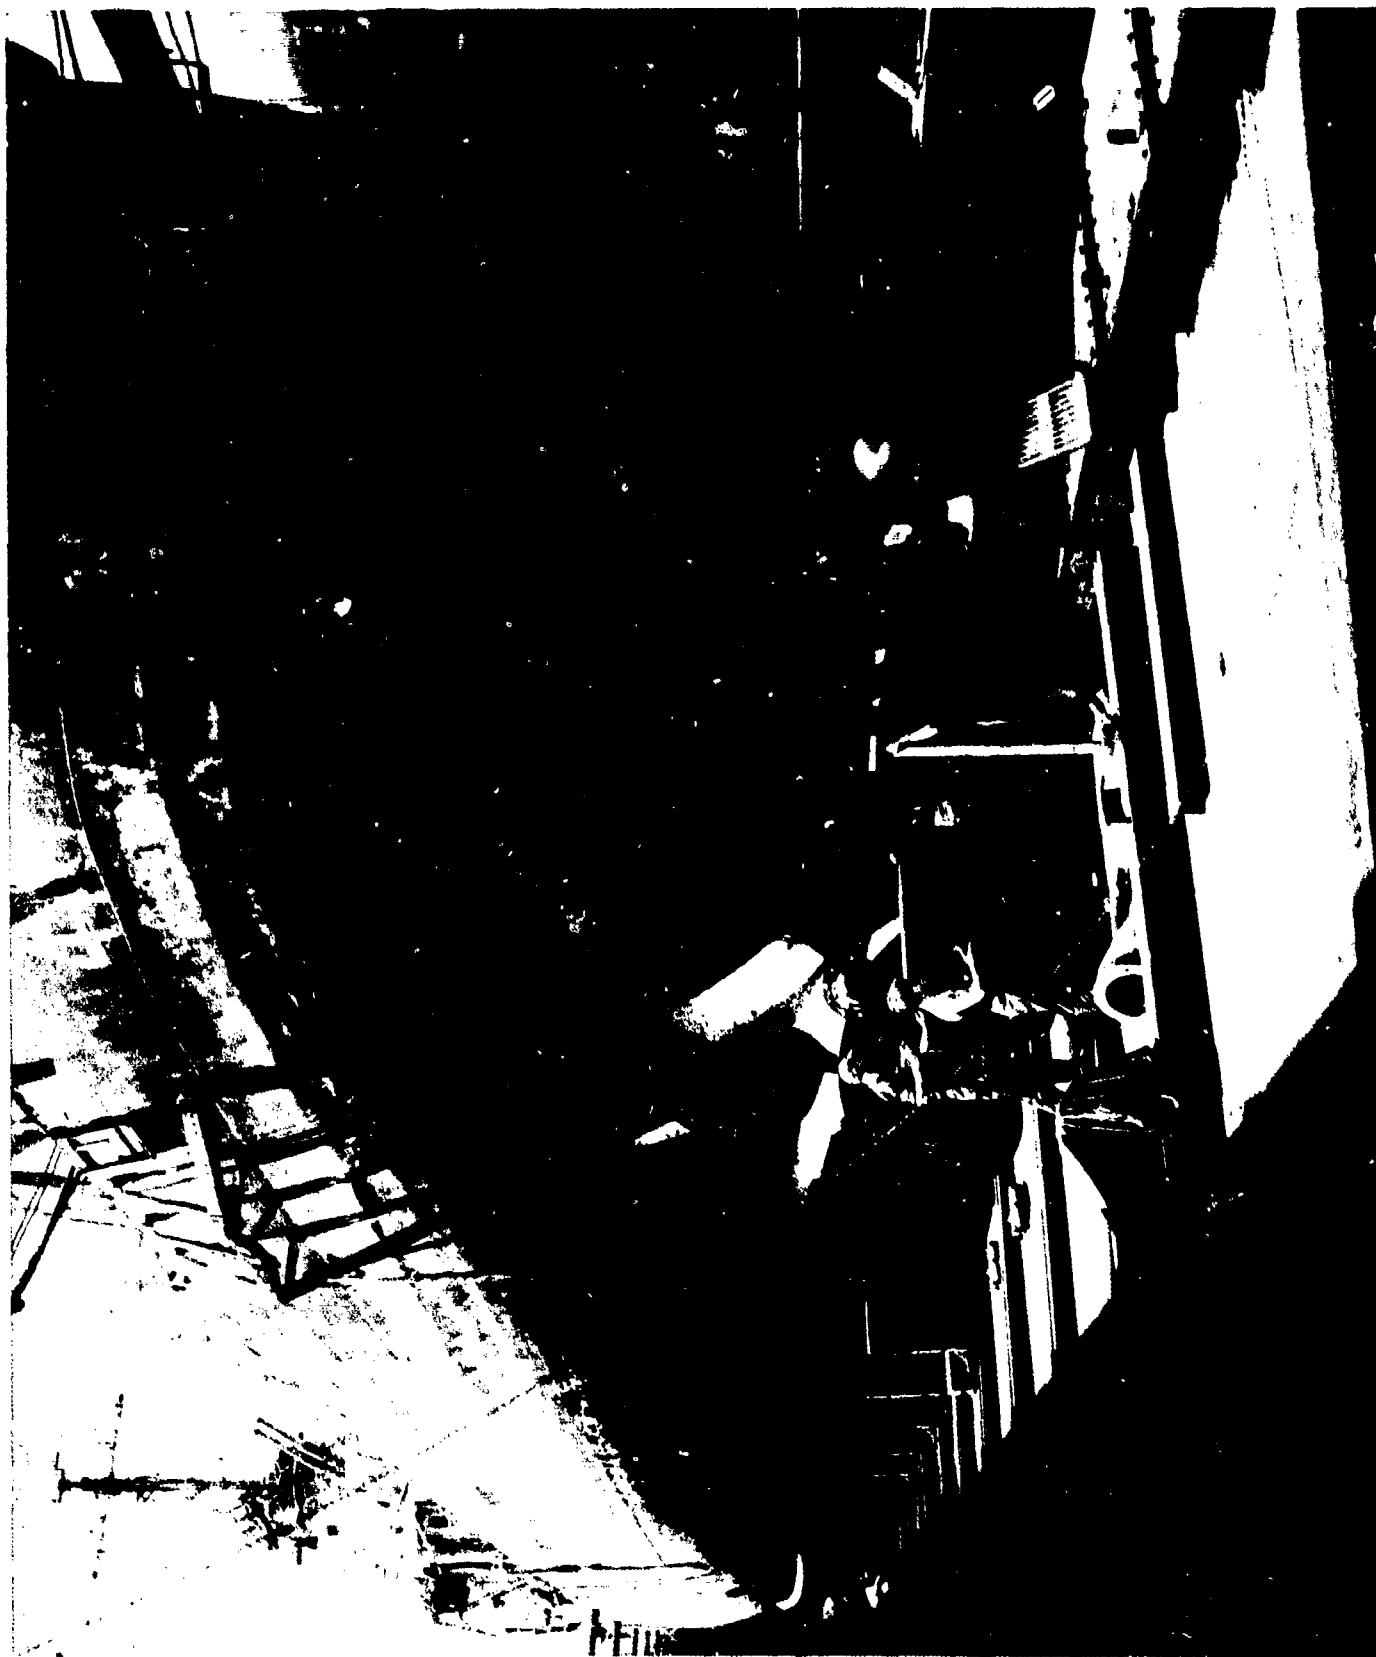
AB-CR-97-4057-4. Port shell and transom, looking forward from astern. Note dishing between longitudinals.

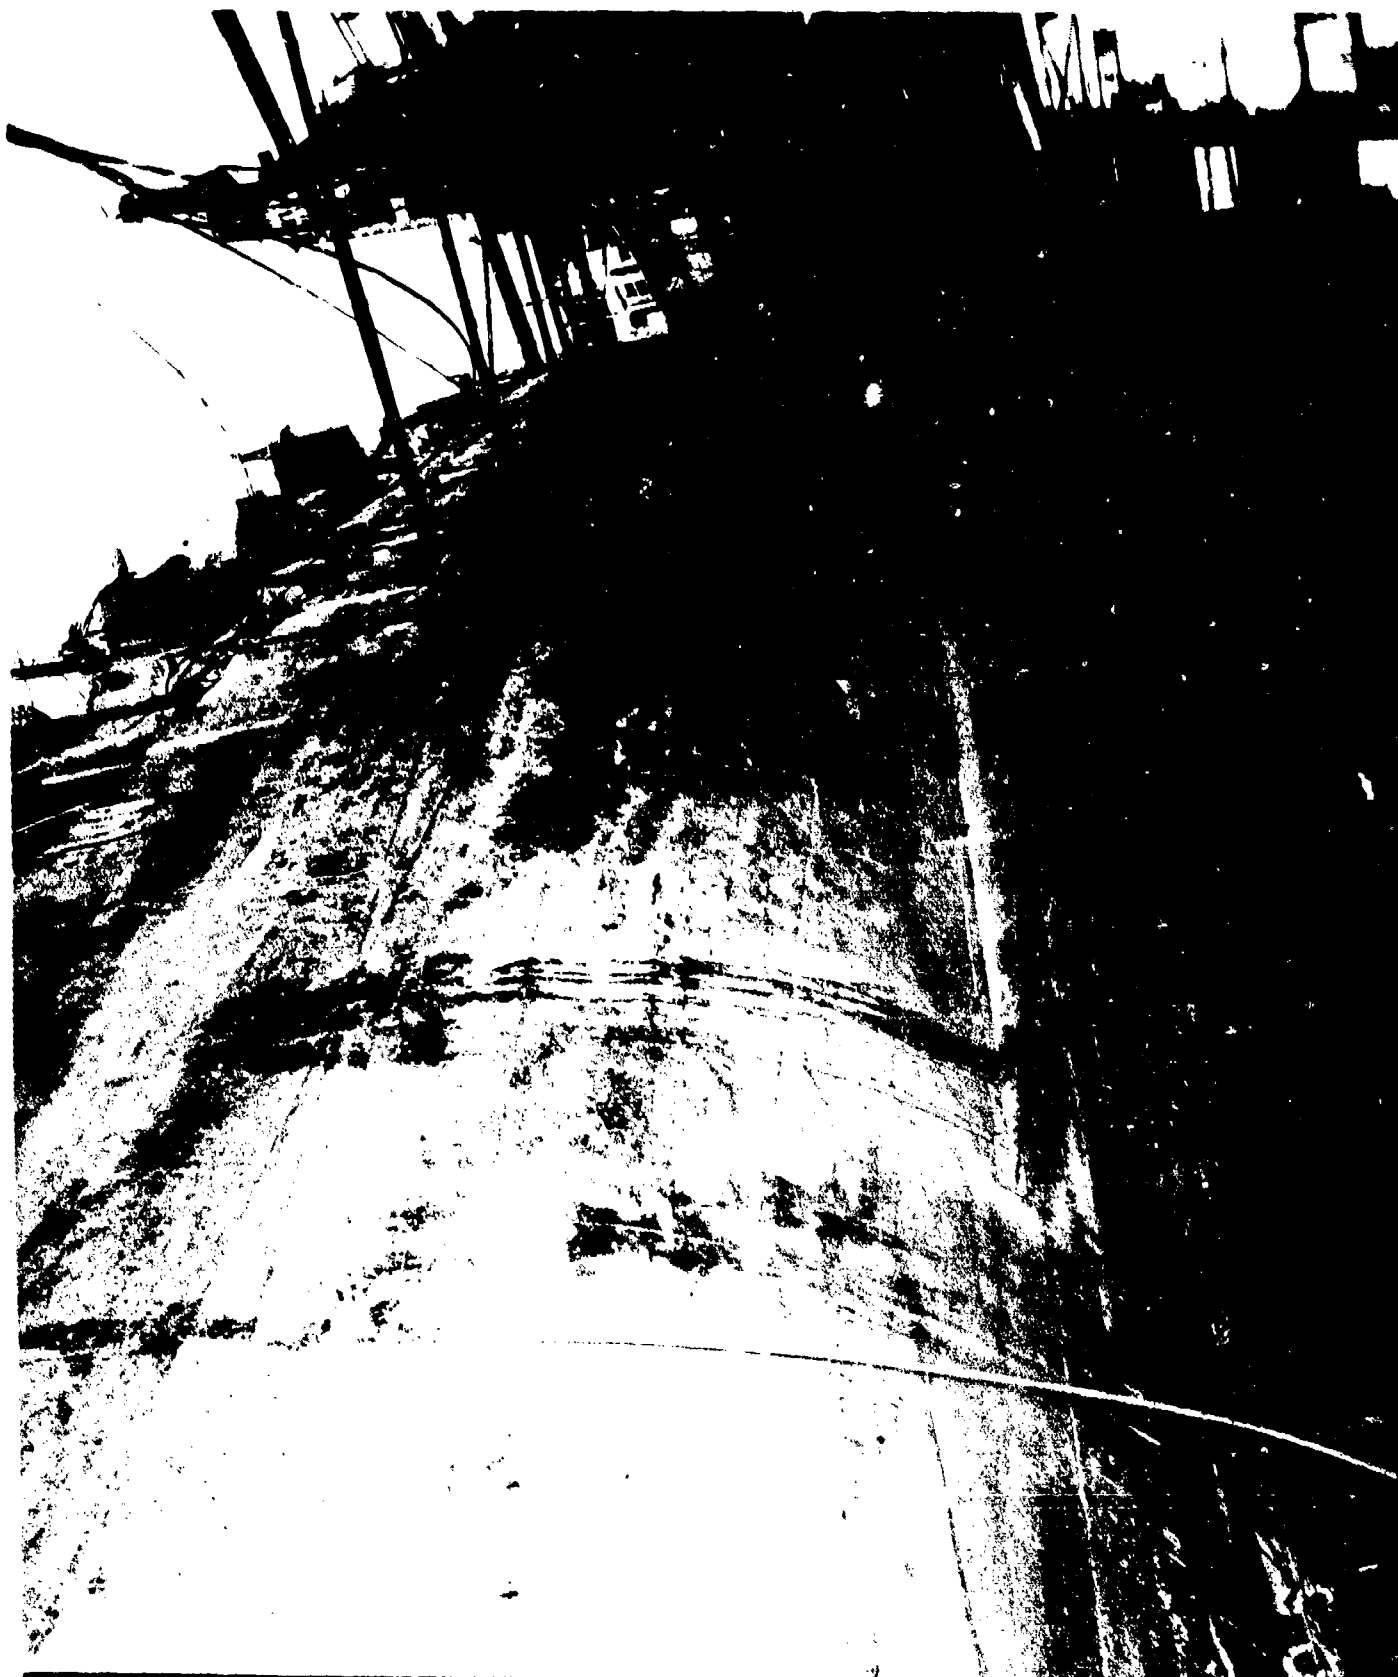
AB-CR-97-4057-6. Starboard shell, looking forward, frames 150-130.

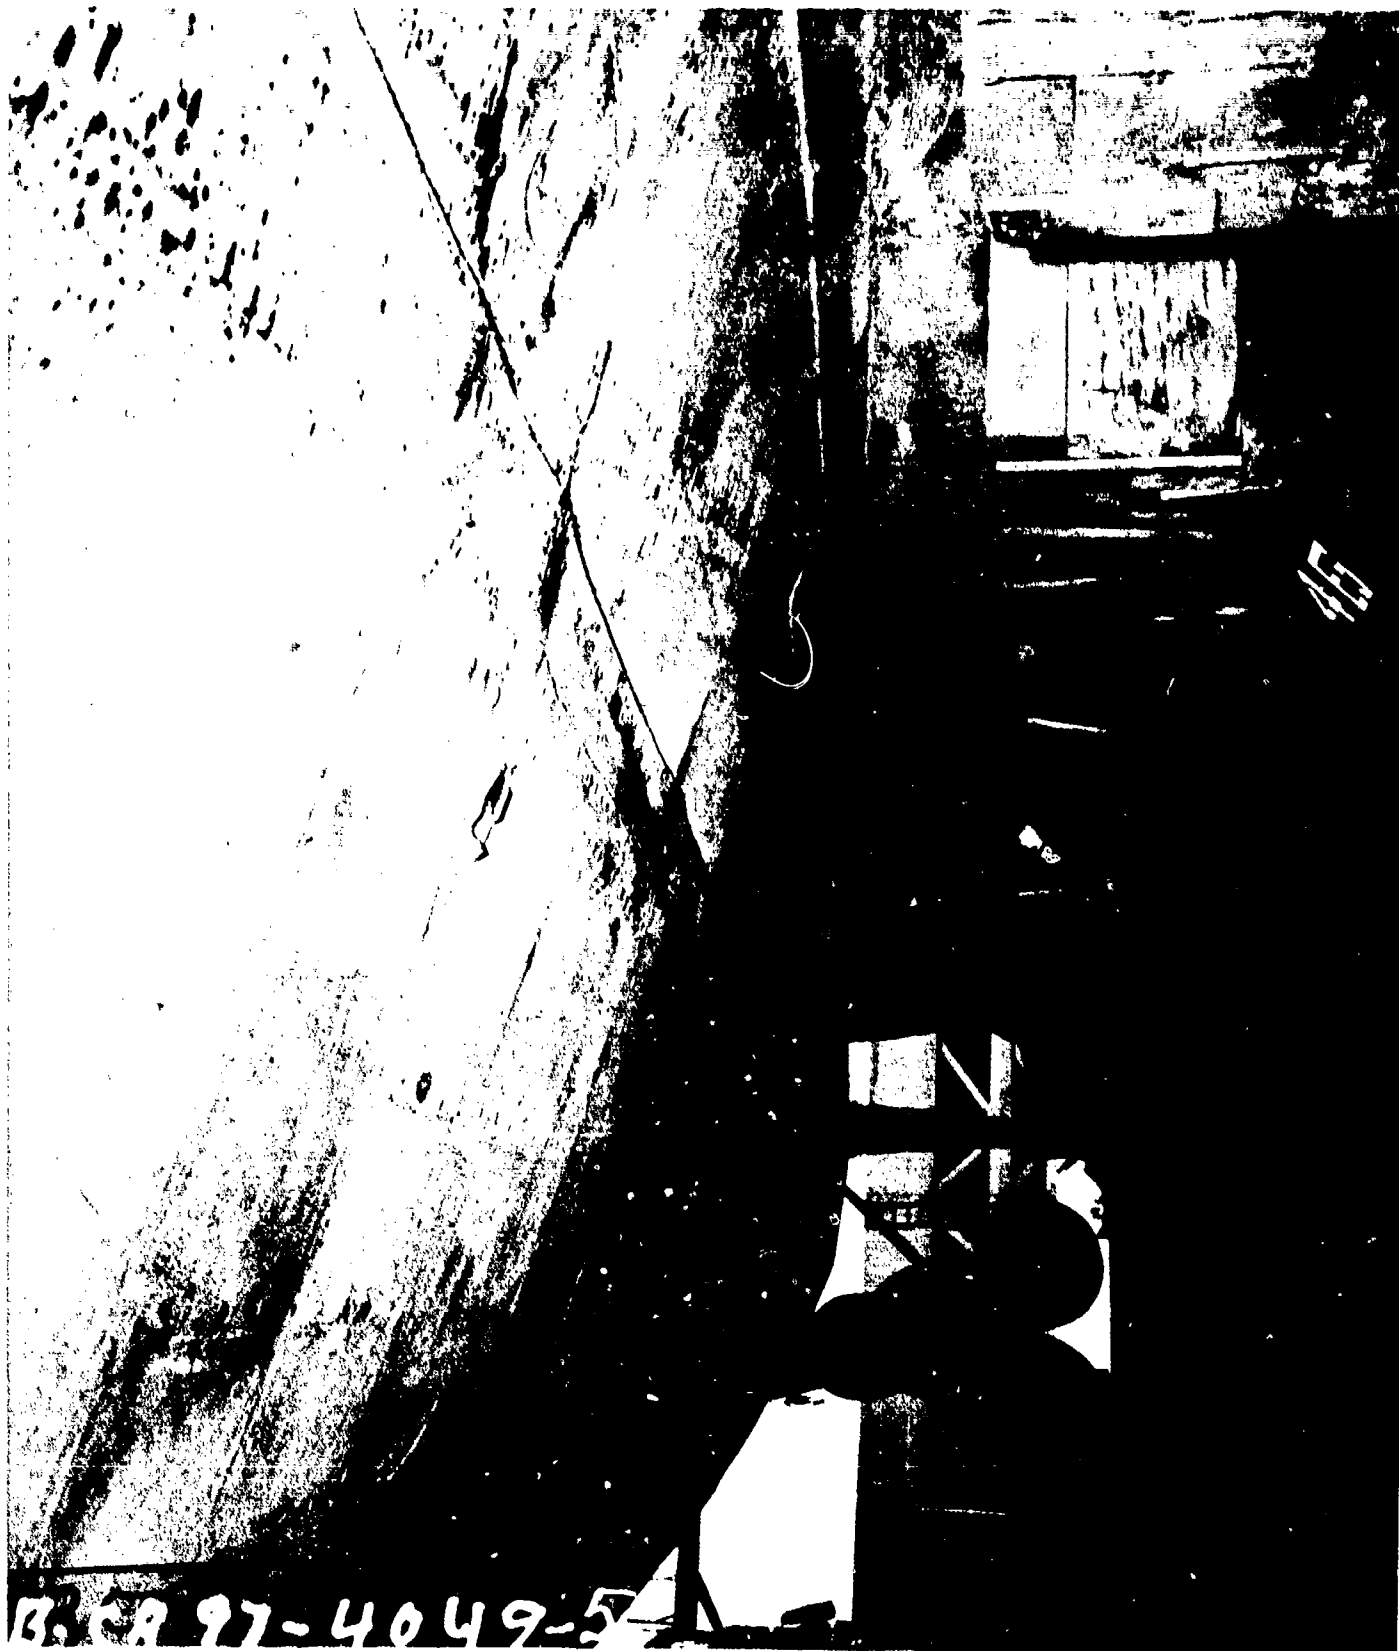
AB-CR-97-4049-5. Starboard bottom shell, looking aft from frame 140.

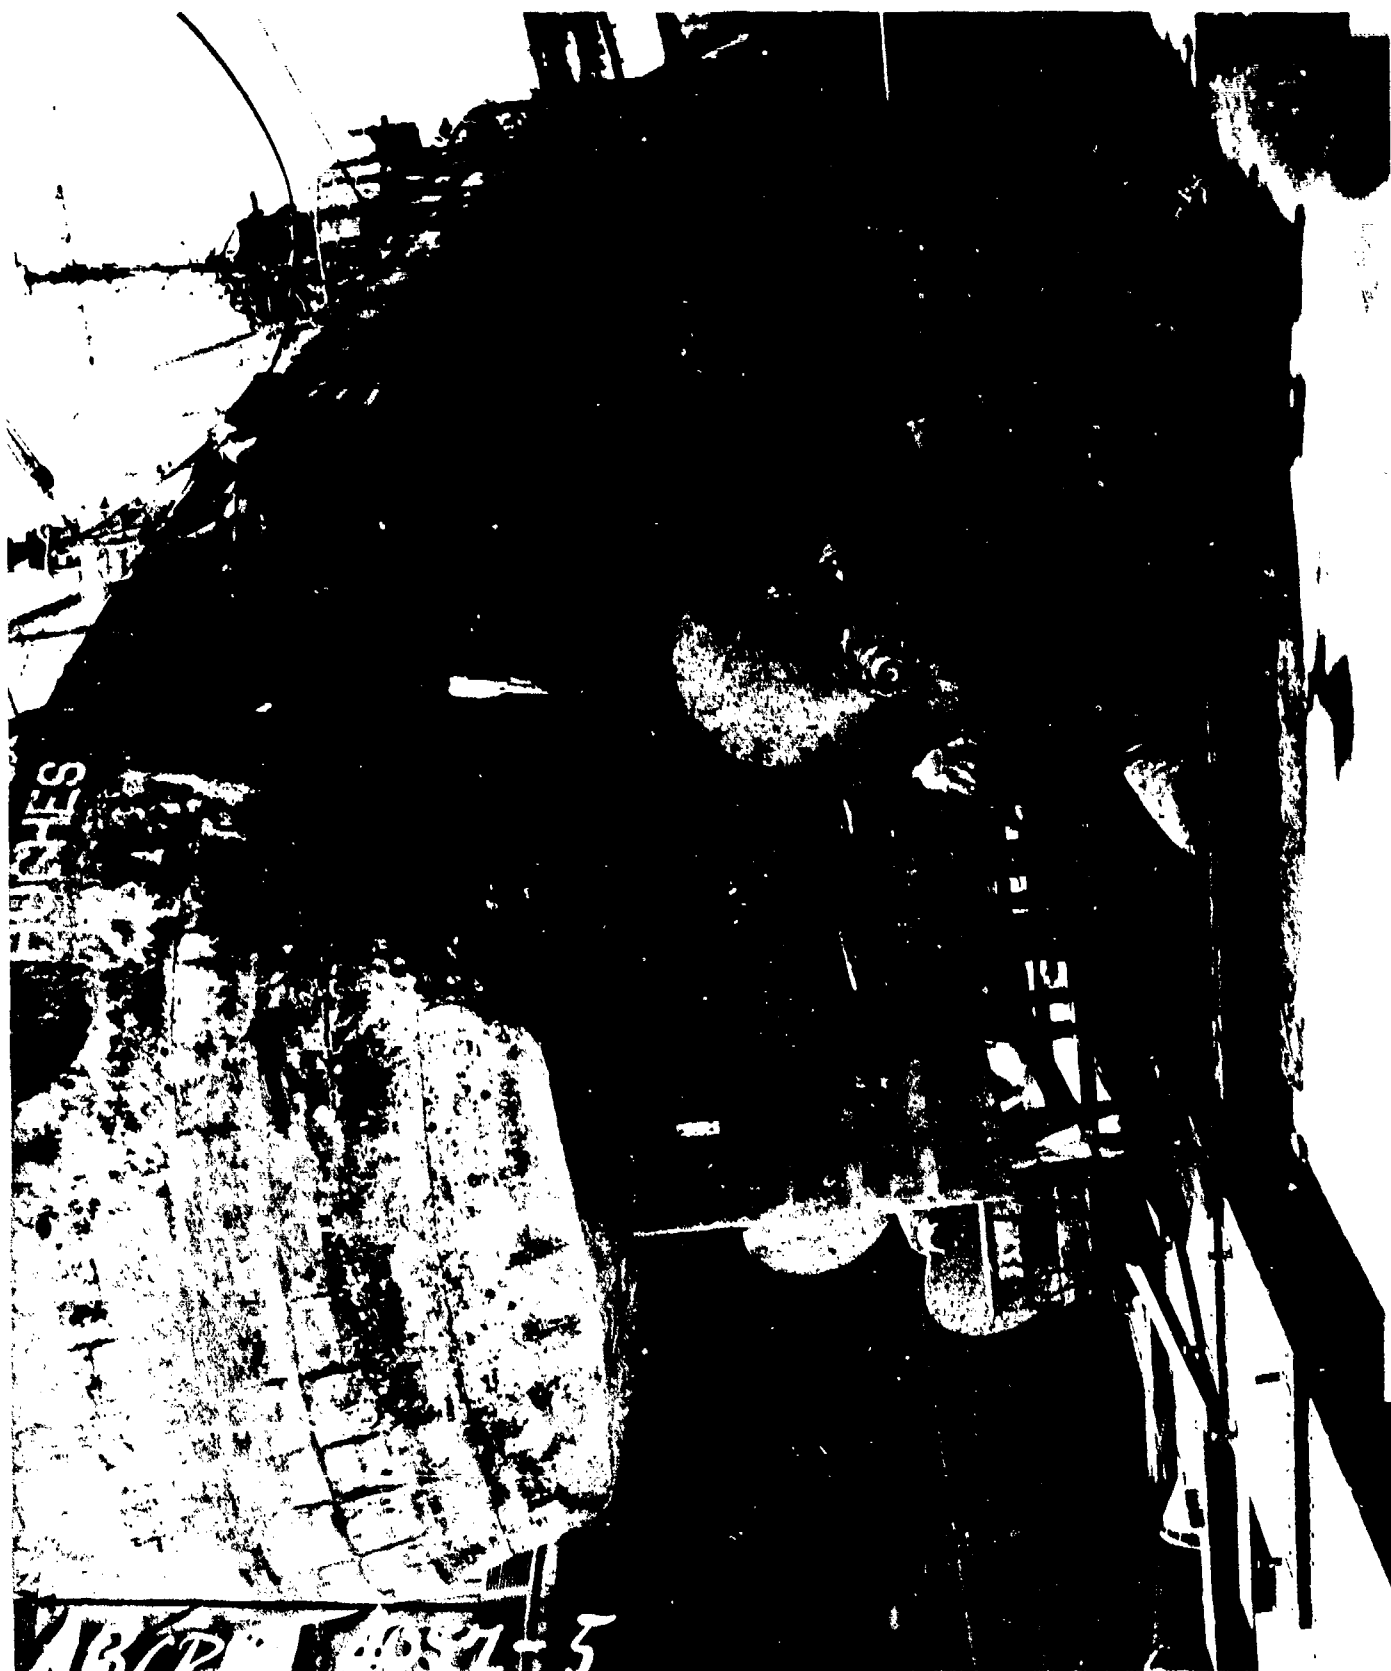
AB-CR-97-4057-5. Starboard shell and transom, looking forward from astern.
